# A Medieval Hall and Cross-Wing House in Queniborough

*by Martin Cherry and Peter Messenger*

86, Main Street, Queniborough is an early-fifteenth century timber-framed house lying to the north of the principal village street about 120 metres west of the parish church. The object of this short article is to draw attention to the building's medieval construction, part of which — the wing — has been firmly dated by dendro-chronological analysis to the early 1430s, and to the subsequent development of the house and its associated out-buildings.

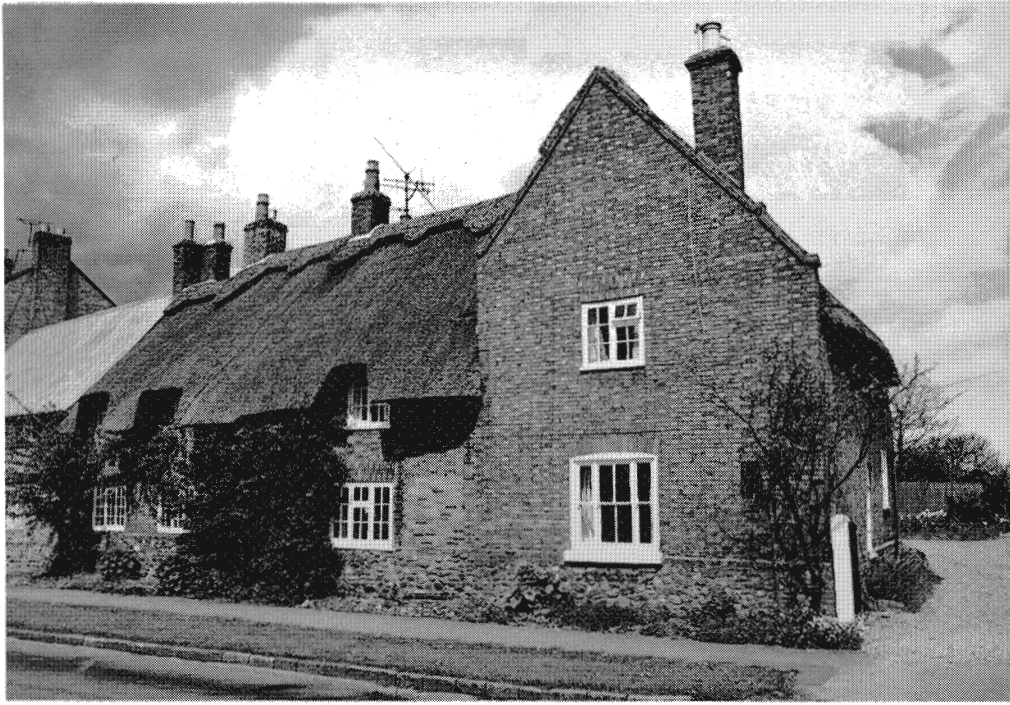
Plate 1: *Hall from the street*

The original house conformed to a common medieval plan type consisting of an open hall range (aligned east-west and running parallel to the street) with a cross-wing to the east. (Plate 1). The tree-ring dating analysis was unable to provide the age of the hall range (because it is not built of oak); however, it is highly probable that this is coeval with the wing. If so, the building is noteworthy in that it combines in a single-phase construction two separate units using different framing techniques, namely a hall range of full cruck construction and a wing of box-frame or, more specifically, of post-and-truss type. In Leicestershire, these different building traditions exist side by side,<sup>1</sup> but there is very little evidence as to how, if ever, the two traditions evolved into a single hybrid. Here we are suggesting that the two forms of construction were suited to different functions within a household and were comfortably fused into a single dwelling. The early history of the building is obscure but it is almost certain that it formed part of one of the medieval freehold tenements of the manor of Queniborough.

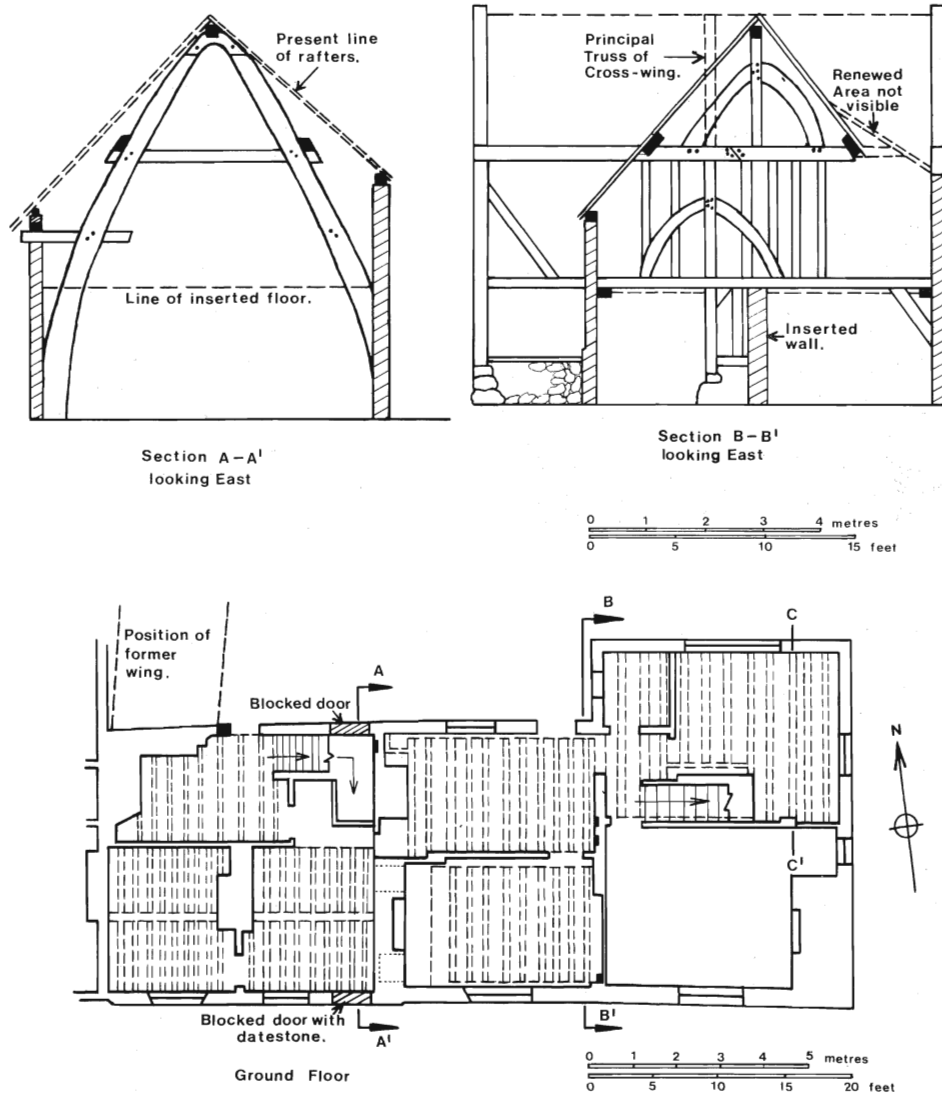
Figure 1: Plan of Hall

**The hall range.** This originally consisted of a one-bay hall with the service end, containing the cross-passage, to the west. Much of the evidence for the service end was obliterated when the building was extended westwards to connect with the neighbouring (but originally detached) cruck-framed house, now nos. 82-84, Main Street. It is possible that the service end was initially open to the roof and separately heated because the cruck truss which divides it from the hall (Fig. 1 marked A-A<sup>1</sup> on the plan), and which was always fully closed, is smoke blackened to both service and hall sides. However, the fact that the cruck blades and the saddle are chamfered and stopped to the service side only, implies the presence of a moderately high-status room, probably a solar over the services, and it seems likely that the sooting was caused by a brazier rather than by an open fire at ground floor level. The hall itself was open. Where original roof timbers survive they are smoke blackened and the infill material to the end partitions is heavily soot encrusted.<sup>2</sup> This infill is composed largely of straw, mud and dung (see Technical Note below). The hall abuts the framed side wall of the cross-wing (marked B-B<sup>1</sup> on the plan), and the roof space at this end of the hall is closed by a king-post and downward curved braces, all of which are set flush with the outer face of the wing wall-plate and securely tenoned and pegged into it.

**The cross-wing.** This is of two equal bays of post and truss construction which originally had close studded panels. The sill is interrupted by the principal posts which are heavily jowled and rest on pad-stones. There are straight and concave braces as well as large tension braces on the side wall between hall and wing.<sup>3</sup> The roof is of the clasped purlin type with wind braces, supporting common rafters between the main trusses which have tie beams, collars and principal rafters. The principals of the central truss diminish above collar level only to thicken out quite markedly at the apex where they are tenoned and pegged. This central truss was closed through its entire height.

The north bay contained the stairs which were centrally placed (near to the position of the present stairs), the joists being tenoned into a trimmer (now removed). Blocked mortices on the underside of the joist marked C-C<sup>1</sup> on the plan indicate the site of the original outer (east) wall. The wing may have been heated by an external chimney stack, possibly of timber-framed construction, and set against this east wall, and the presence of a pre-existing structure at this point may explain the otherwise awkward and narrow lateral extension of the wing which necessitated the introduction of sprocketed rafters at this point.

Smoke blackened wall infill from B-B<sup>1</sup>.

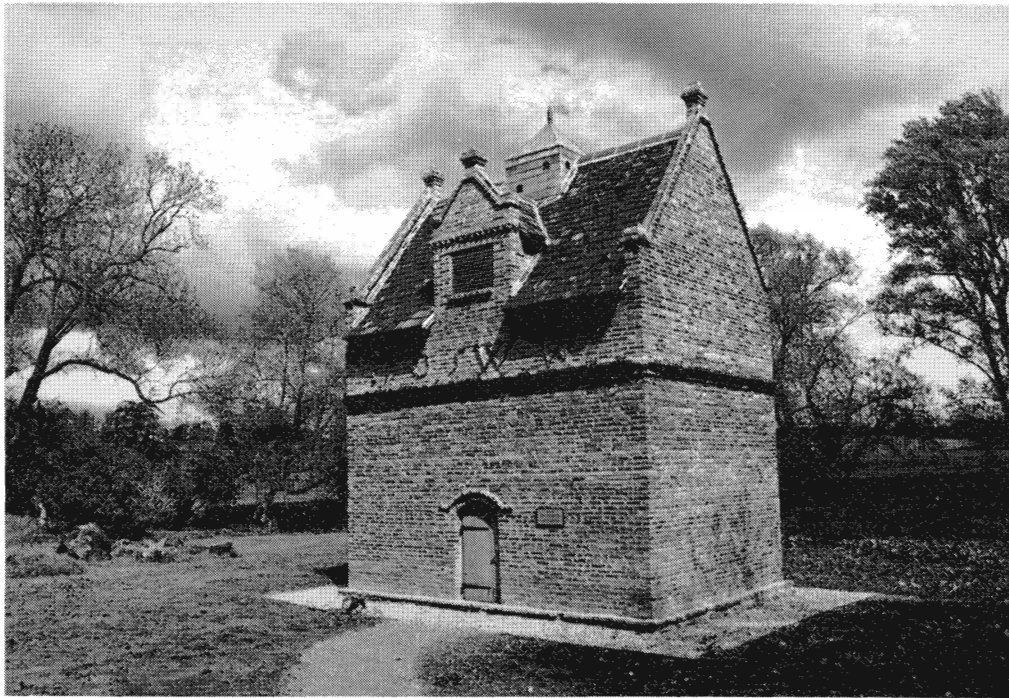
Plate 2: *Dovecote 1705*

The only addition William While seems to have made was the erection of a dovecote which originally stood to the rear of number 86. (Plate 2). Dated 1705 and bearing the initials WW the building was threatened by new development in 1985 and a decision was made to dismantle and re-erect it on a new site to the east of the church. This work was carried out by the Building Craft Unit, an M.S.C. Community Programme team supervised by the conservation staff of the County Council. The dovecote is built of brick on a

low granite plinth with a Swithland Slate roof. It contains well over 600 nesting boxes. Medieval dovecotes were the property of the lord of the manor; however, by the end of the seventeenth century examples are known to have been built by freeholders usually with the permission of the lord of the manor.<sup>10</sup> Presumably this was the case in Queniborough for it was not until 1761/2 that the freedom to build a dovecote was granted to any freeholder on his own land or by a tenant with his landlord's permission.
