Fire, Fast and Feast: The Kitchen of Leicester Abbey

Richard Buckley and Steve Jones

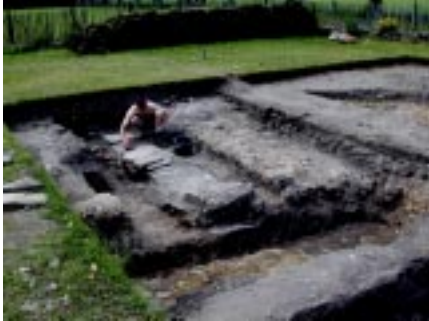
Above: Excavating the kitchen drain.

shell, probably accumulated from the surroundings of the kitchen. A stone-lined and stone-capped drain running from the kitchen to the south was also identified and appeared to correspond with one on the 1930s excavation plan. It contained fragments of shell and a single sherd of 15th or 16th century pottery. Numerous fish scales and small bones were also found within the fill and had probably been washed down the drain following food preparation within the kitchen. Other remains included bones of rodents, possibly rats living in the drain.
